Tribological Challenges in Wind Turbine Technology

Gary L. Doll, Ph.D., FASM
Timken Professor of Surface Engineering

gdoll@uakron.edu
330/972-7350
15 November , 2011

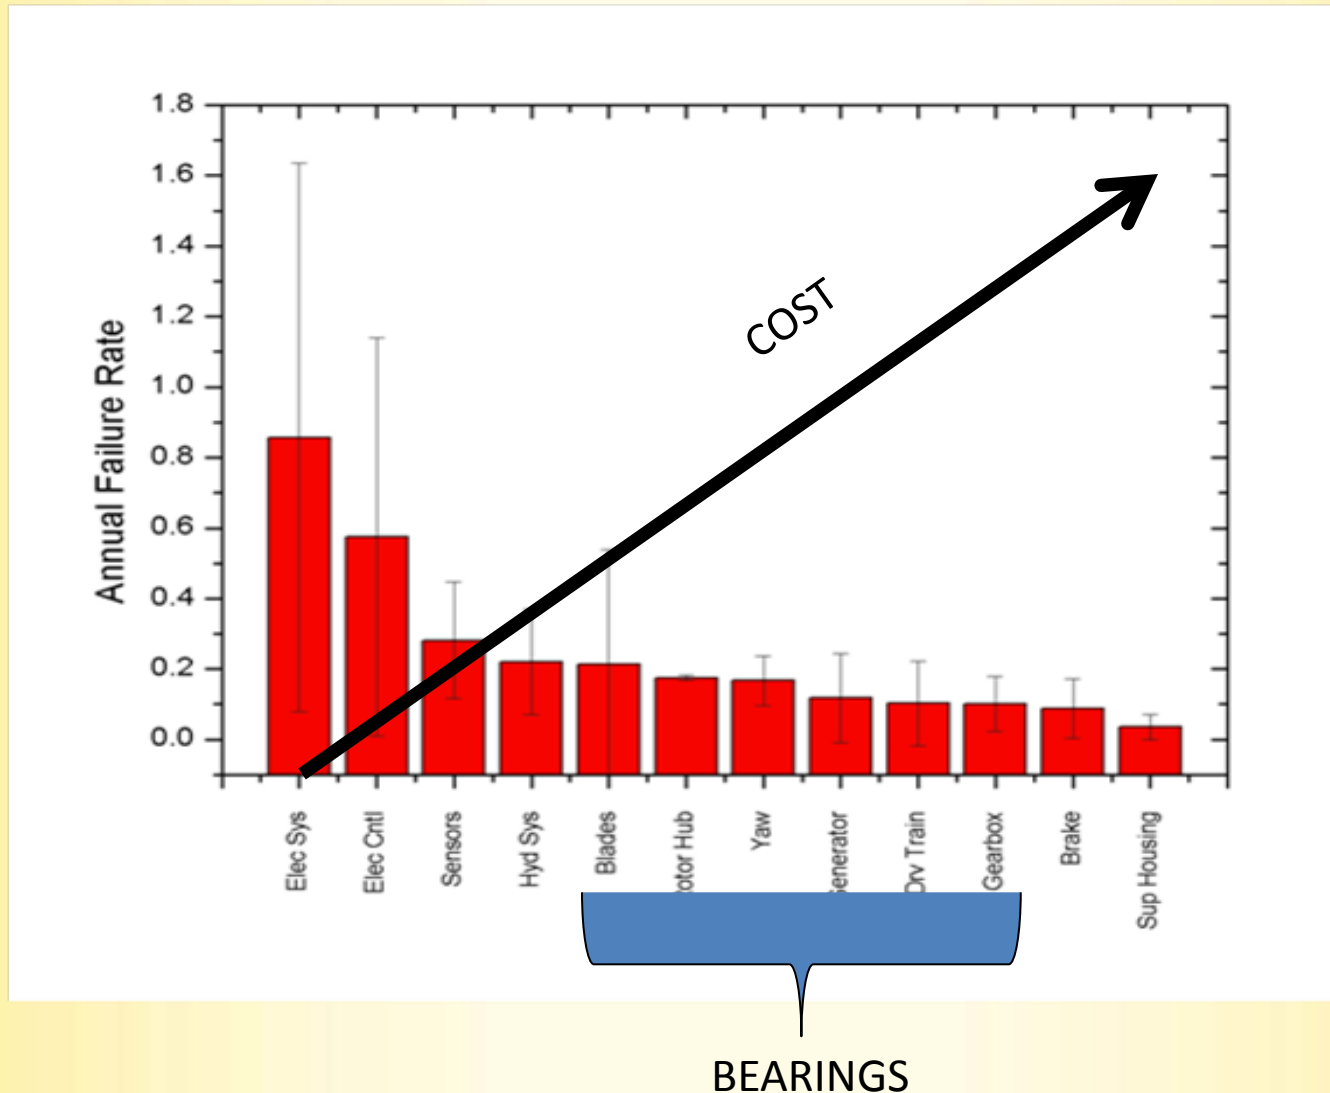
Component Reliability

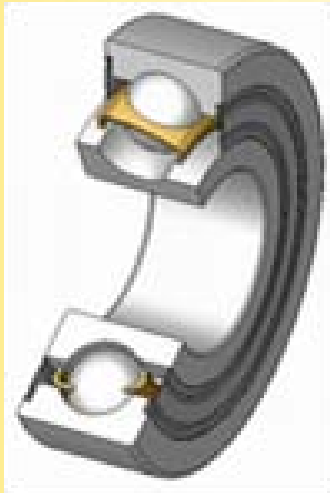
BALL

*Generators
Yaw Bearings
Pitch Bearings*

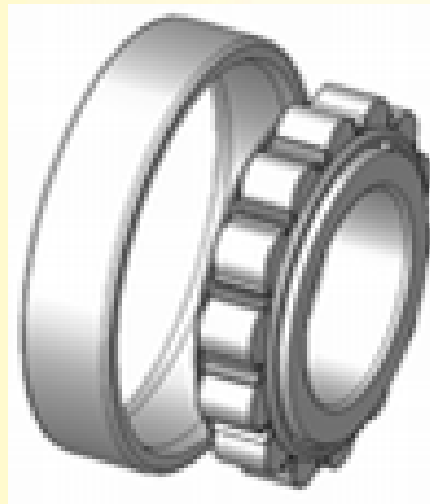
**CYLINDRICAL
ROLLER**

Gearboxes

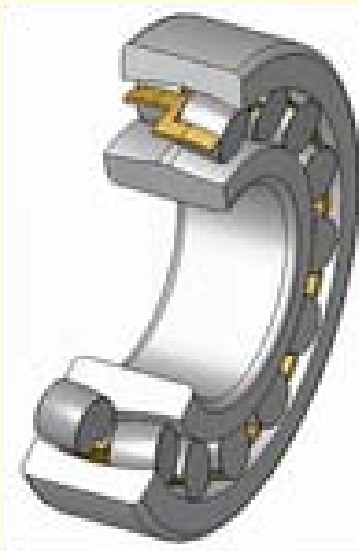
**SPHERICAL
ROLLER**

*Main Shafts
Gearboxes*

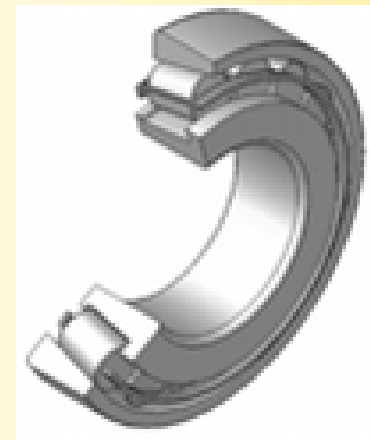
**TAPERED
ROLLER**

*Main Shafts
Gearboxes*

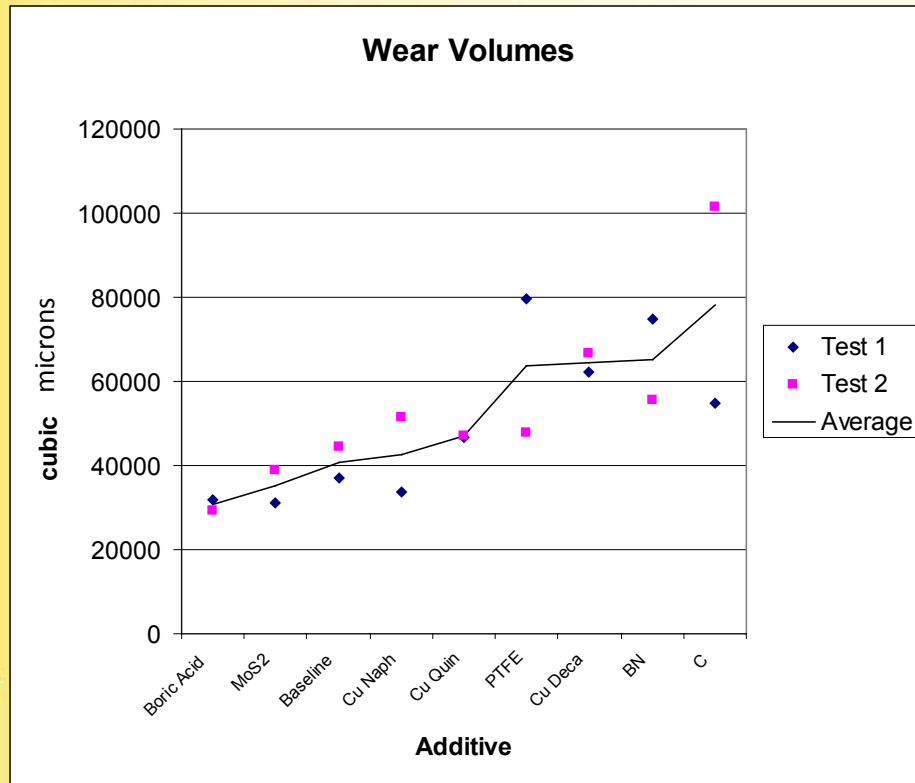
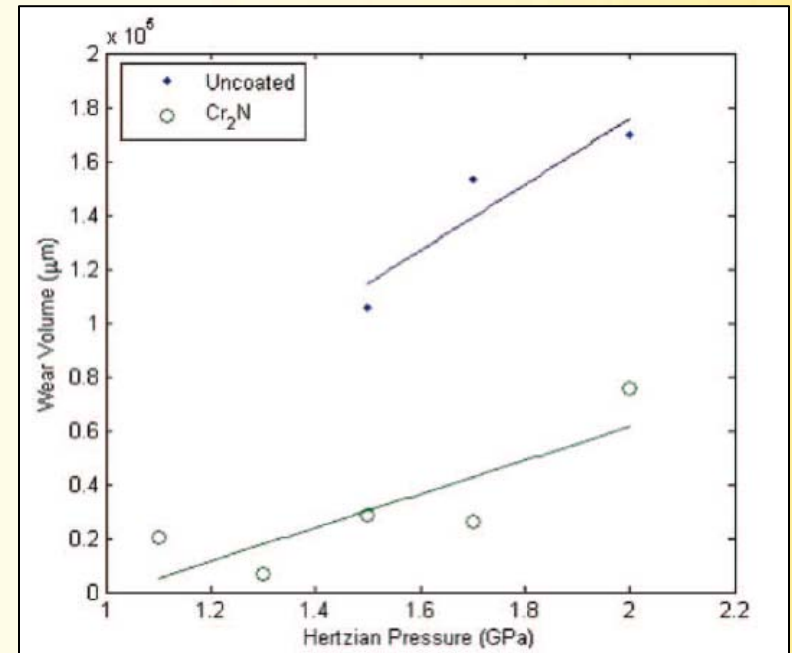
WC/aC:H : no observable wear!

- Harris et al. (2009): avoid operating the pitch and yaw bearings under these very small oscillations and rotate the bearings as often as possible to redistribute grease to the rolling element contacts.
- Greases with adequate base oil viscosities and good anti-wear additives.
- Coat the raceways or rolling elements per Leonard et al. (2010).

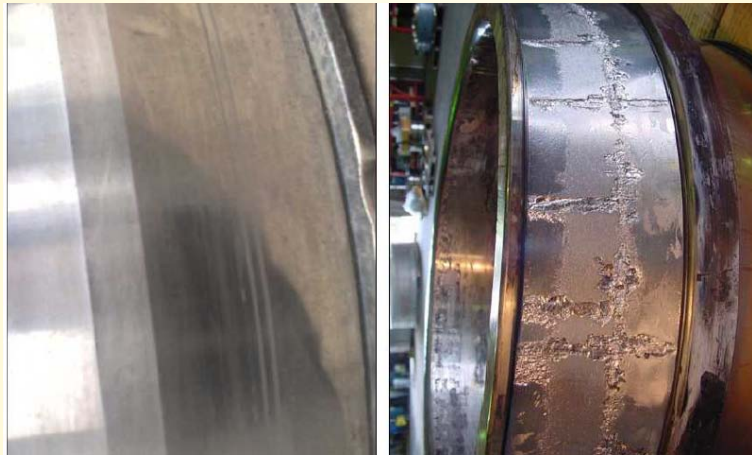
- Onset of micropitting (left): two wear tracks have emerged in the center of the raceway.
- As micropitting continues, material is worn away leading to a loss of the design contact geometry in the center and increasingly higher stress concentrations at the edges of the wear track.
- Fatigue spalls initiate at these areas of high geometric stress concentrations and propagate to the center of the raceways.
- Raceway spalling is not due to classic surface initiated or inclusion related fatigue on which the predicted bearing life is calculated.
- Raceway spalling is due to loss the designed contact geometry from micropitting wear and a concomitant increase in geometric stress concentrations at the edges of the roller/raceway contact.

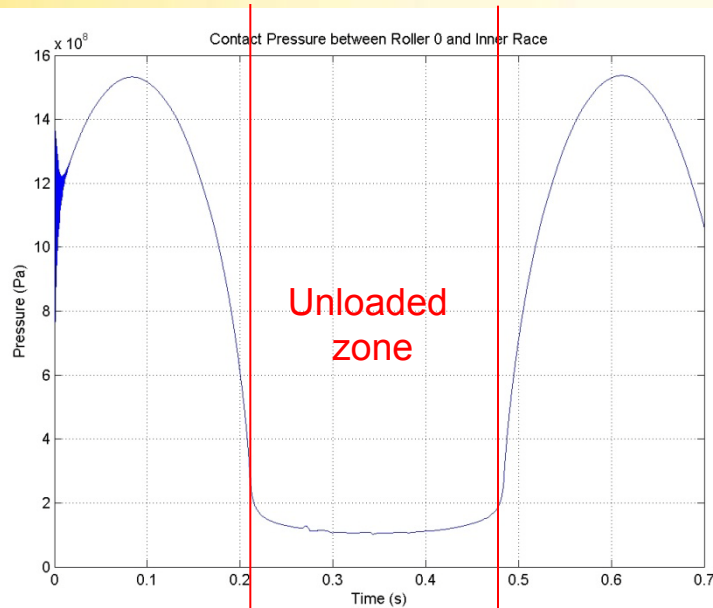
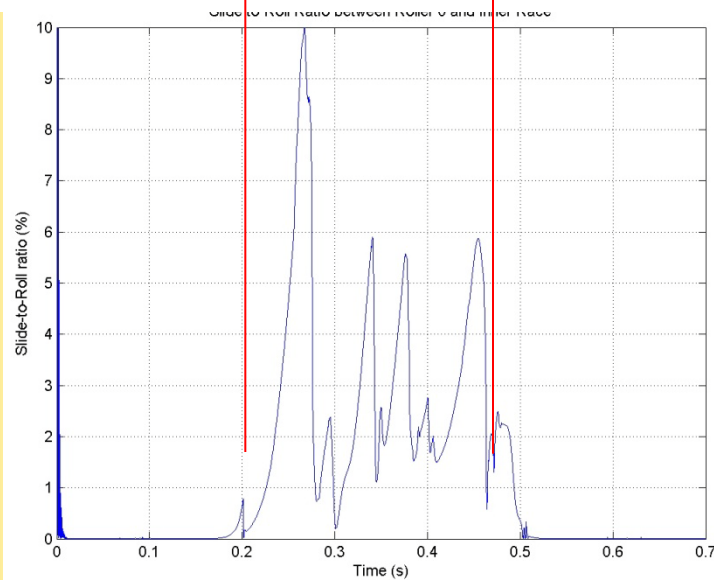
- Decreasing loads promotes more roller sliding
- Transient conditions (loads and accelerations) increases roller sliding

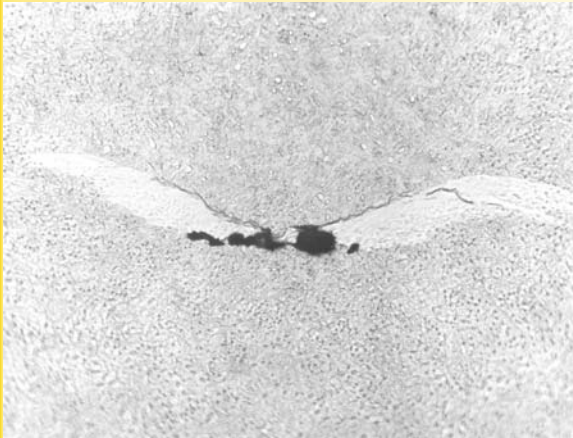
“Normal” Butterflies at Inclusions

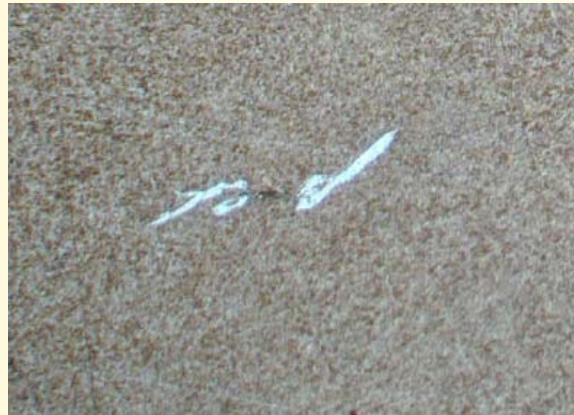
“Abnormal” Butterflies (IrWEAs) at Inclusions

- Extremely high content of butterflies in each cross section.
- Typically evenly distributed around the bearing widely branched white etching sub-surface alterations growing parallel to the surface, perpendicular to the surface or in variable directions.
- Associated with the use of oil lubrication (mineral, PAO and PAG).
- Black Oxide helps
- Not observed in case-carburized rings
- Inner rings usually, rarely outer rings

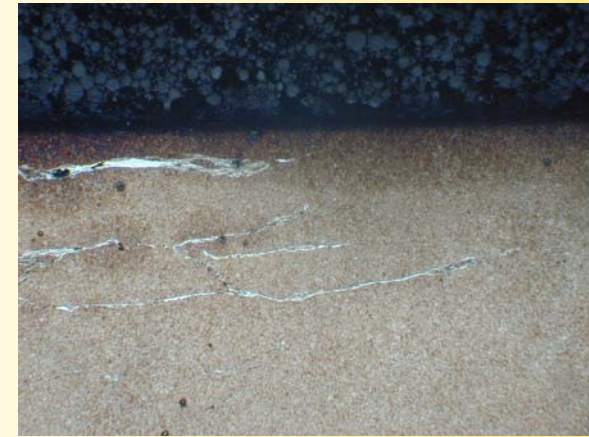
Crack Network

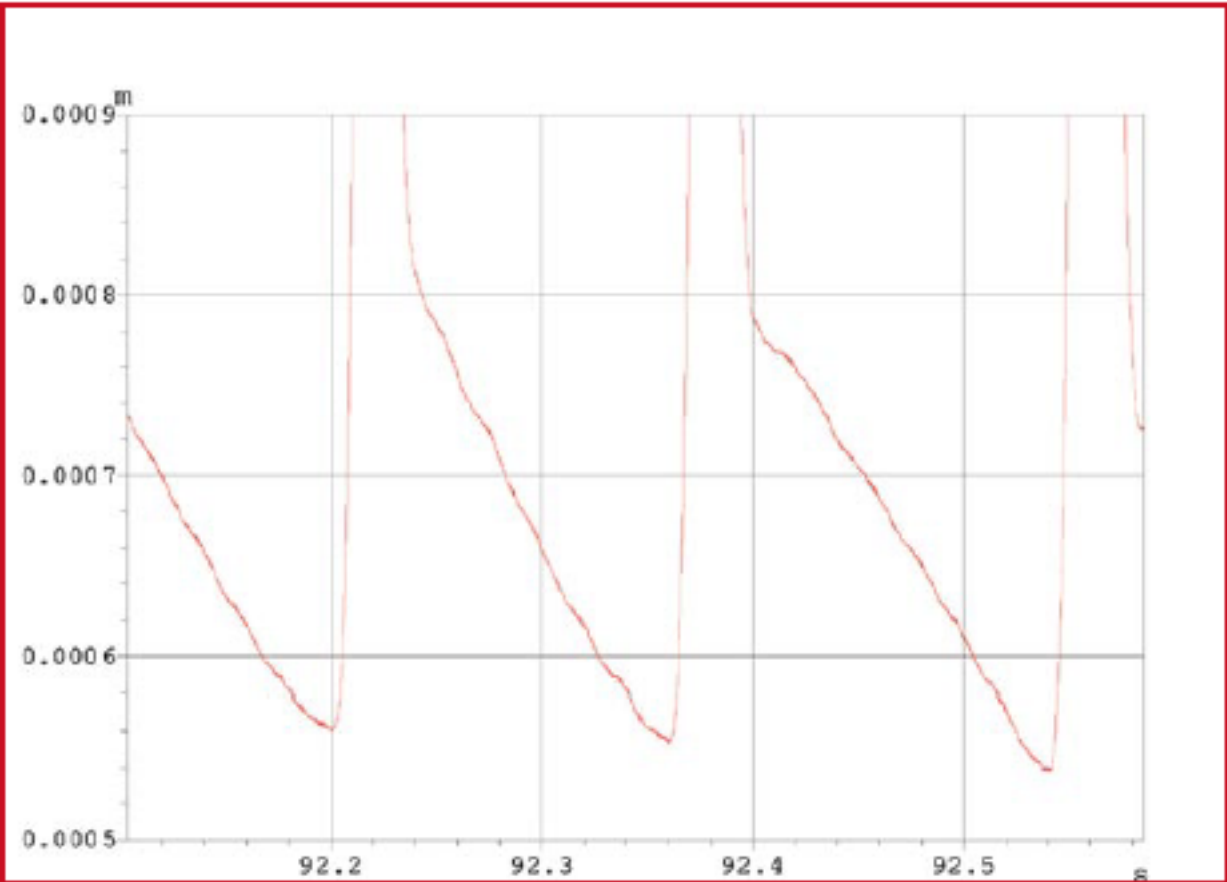
Fig. 16: Detail of bearing axial displacement from test 6, showing over 200µm skew.

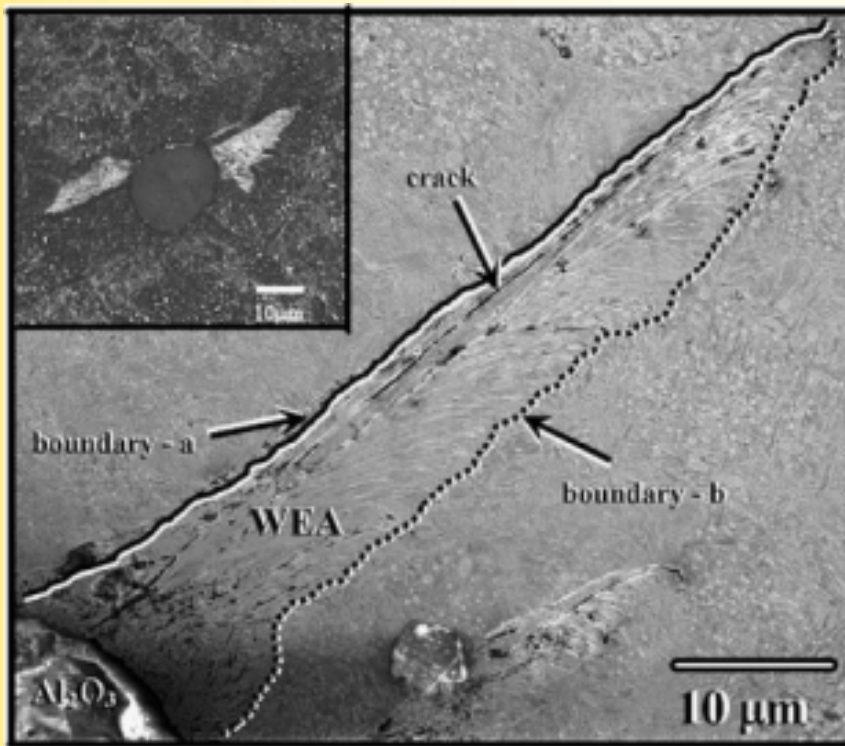
- Voids & microcrack initiate at inclusion/steel interface
- Microcracks agglomerate & propagate along ferrite wings

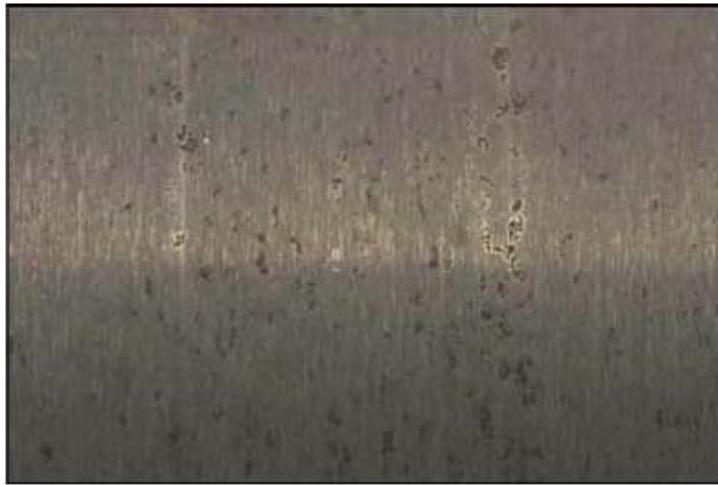
Electrical current damage on the outer raceway of a bearing: (a) Photograph of the body raceway surface; and (b) Cross section of a pit, mounted, polished, nital etched and magnified 600x showing the removed material, rehardened and retempered layers.

- Root Cause:
 - High-frequency currents induced in the shaft can pass through the rolling elements causing extreme local heat and small burnt pits in the bearing raceways.
- Possible Solutions:
 - Ceramic balls for rolling elements in the bearing, (hybrid bearings). But has not always worked.
 - Srinidhi et al. (2009) Retainer material – no effect, but there was a significant difference between oil and grease.
 - Electrical insulating coatings (Al_2O_3) on rings.
 - Dry Oils with high dielectric strengths.
